Dornier 328

This sheet transmits Revision 3 to Alert Service Bulletin ASB-328-27-036 titled: Flight Controls – Inspection of the Rudder Spring Tab Lever Assembly.

No. ASB-328-27-036

Title: Flight Controls - Inspection of the Rudder Spring Tab Lever Assembly.

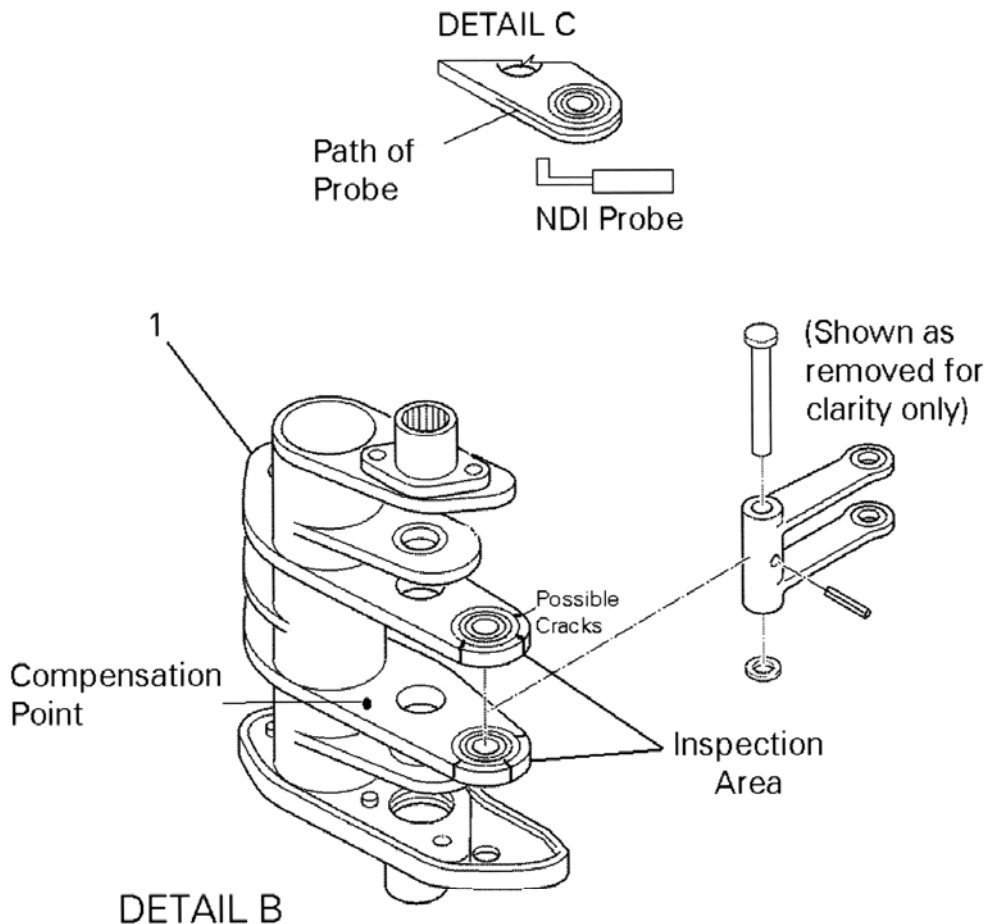
**Fig. 2**Model Dornier 328Rev. No. 3No. ASB-328-27-036Rev. Date. Feb 08, 2008Date of Issue Feb 12, 2003Page 7 of 7

There is a possibility of a failure of the rudder flight control system due to cracks in the spring tab lever assembly bearing lugs.

- (1) Do a detailed visual inspection of the rudder spring tab lever assembly Pt. No. 001A272A4020 (item 1) refer to detail B figure 2. Inspect for signs of cracks around the edges of the two lugs which retain the swaged bearings.
- (2) NDI Instrument Calibration.
 - (a) Operate the test equipment as given in the manufacturers instructions.
 - (b) Set the necessary frequency to 2,0 Mhz.

- (c) Calibrate the instrument using the calibration standard as given in the manufacturers instructions.
- (3) Do an Eddy current NDI on both bearing lug peripherals, refer to figure 2.
 - (a) Set the necessary frequency to 2,0 Mhz./1,0mm penetration depth.
 - (b) Put the probe on the compensation point near to the inspection area and set the lift-off as necessary, refer to figure 2.
 - (c) Do the inspection as given in figure 2. Use the probe position and scan along path movements as illustrated, refer to detail C figure 2.

CAUTION: NO CRACKS ARE PERMITTED. IF CRACKS ARE FOUND CONTACT 328 SUPPORT SERVICES GMBH WITH ACCOMPANYING DETAILS AND PHOTOS ETC. INCLUDING NDI TEST EQUIPMENT USED AND SETTINGS.

- (4) If a crack is found then a replacement lever assy (item 1) must be installed, proceed to Para. C. If no crack is found proceed to Para. D.
