Model Dornier 328

No. ASB-328-76-034

Date of Issue Nov 16, 2001

Title: Engine Controls-Quality issue with Engine Control Cables.

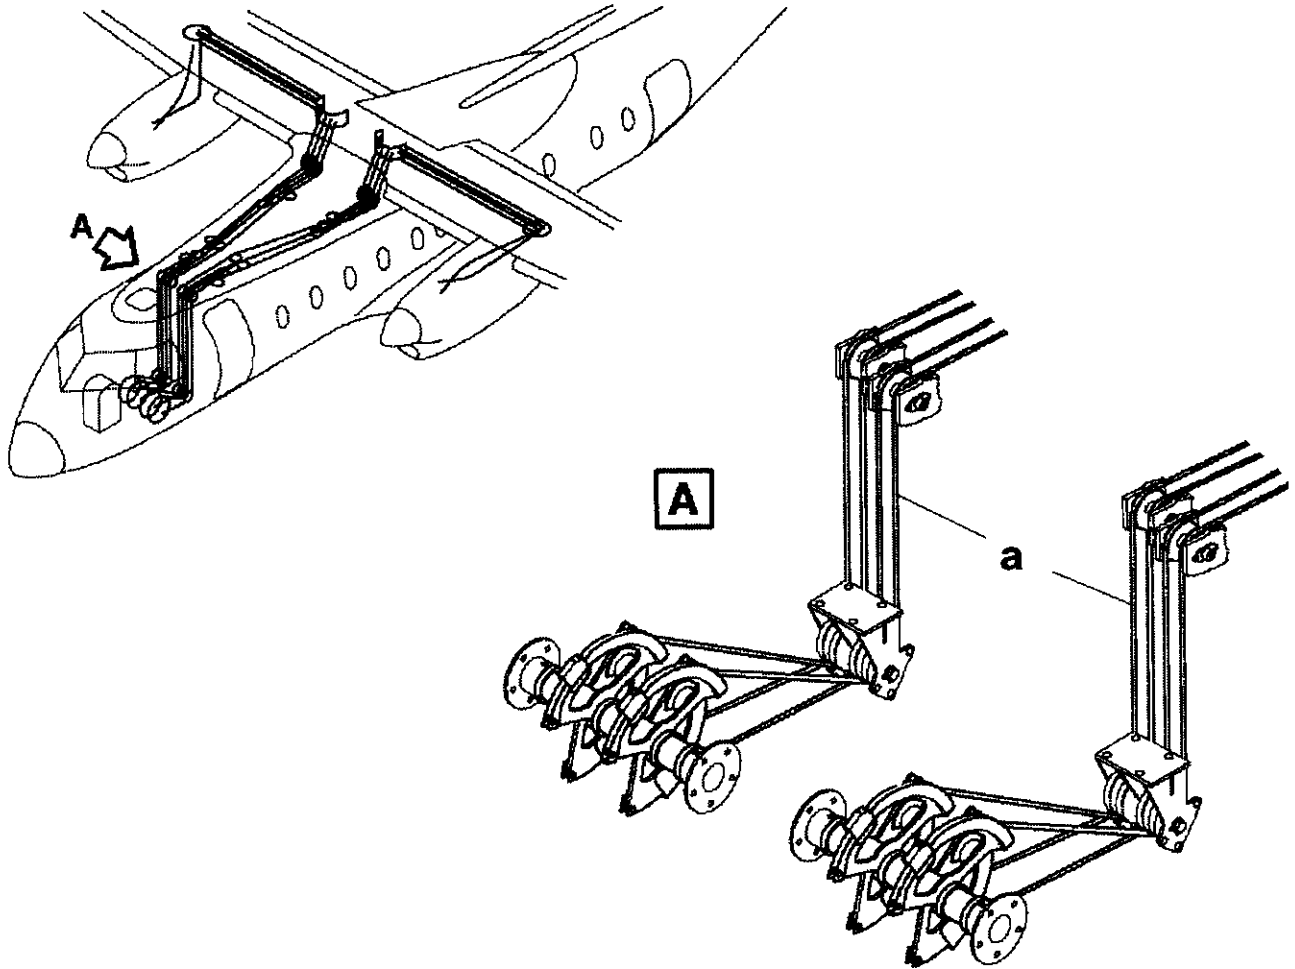
Fig.1

After the Control Cable manufacturer (SARMA) performed destructive tests evidence of cracks were found on the end fittings of a batch of cables.

The following Engine Control Cables are not to be used for assembly on aircraft:
Engine Control Cable P/N: 001A761A1130016.
SARMA P/N: FFC 7825.
Manufacturing Batch No: 1000144210 (see aircraft delivery documentation).
Note: Cables ordered from Fairchild Dornier before 05/Nov/2001, with different batch No's are not affected.

1. Inspect cables (item a) for batch No. 1000144210 see fig.1.
2. If this batch No. is found on the cable end fitting remove and replace the cables in accordance with AMM JIC 76-11-13 for a cable with a different batch No.
