ASB-328J-28-018

Title: Fuel – Inspection of Fuel Line Clamps

Dornier 328-300

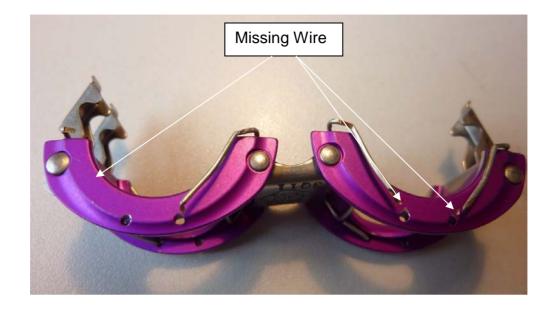
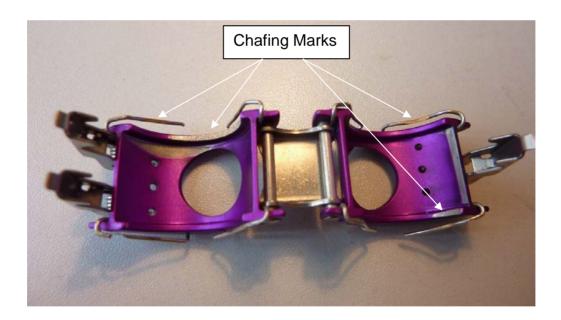
Figure 1: Examples of Reported Damage

Chafing of fuel line clamp bonding wires inside feeder tank.

328 SSG received reports of damaged bonding wires on fuel line clamps in post SB-328J-28-241 installations. The basic clamp function is not impaired, but proper bonding and thus lightning protection might be affected. Refer to Figure 1.

In addition, chafing marks on jet pump inlet, connection part and fuel lines occurred.

Parts with chafing marks beyond defined limits must be replaced.

- 1) Inspect all Hydraflow fuel line clamps at locations A-D for damage of bonding wires in the area. Take pictures of each location for reporting purposes. Refer to Figure 2.
- 2) Open clamps and remove them from tank. Record installation locations.
- 3) Visually inspect clamps for worn or missing bonding wires. If you find worn or missing bonding wires, replace clamp and report the location.
- 4) Visually inspect the jet pump outlet, connection part and fuel lines for chafing marks. Remove parts from tank if chafing marks are found. Refer to the related AMM JIC's.

5) Measure depth of chafing marks and compare to the replacement limits given in table 1.

- 6) Discard parts if depth of chafing is more than the replacement limits.
- 7) Install new parts, and all parts removed in step 4) which are in the replacement limits, to tank. Refer to SB-328J-28-241.
- 8) Check installation of jet pumps, connection part and fuel lines for correct alignment and correct if necessary. Maximum allowable deviation is 1 mm.
- 9) Install clamps. Refer to SB-328J-28-241. Make sure, the alignment is correct.

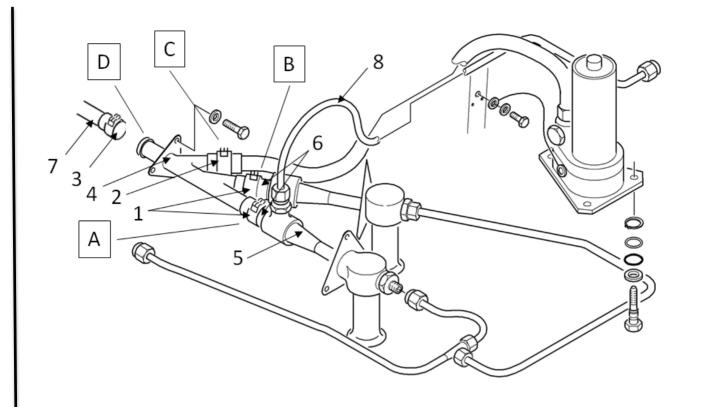
Figure 2: Clamp Identification and Findings for Reporting

NOTE: LH installation shown. RH installation mirrored.
