ASB-328-27-039**Title: Inspection of the Elevator Pulley Support Bracket****1. PLANNING INFORMATION****Effectivity**Dornier 328-100.
EASA TCDS A.096.
Serial-No's: All aircrafts**Reason**

Model	<u>Dornier 328-100</u>	Rev. No.	_____	No.	<u>ASB-328-27-039</u>
		Rev. Date.	_____	Date of Issue	<u>Dec. 16, 2011</u>
				Page	<u>1</u> of <u>4</u>

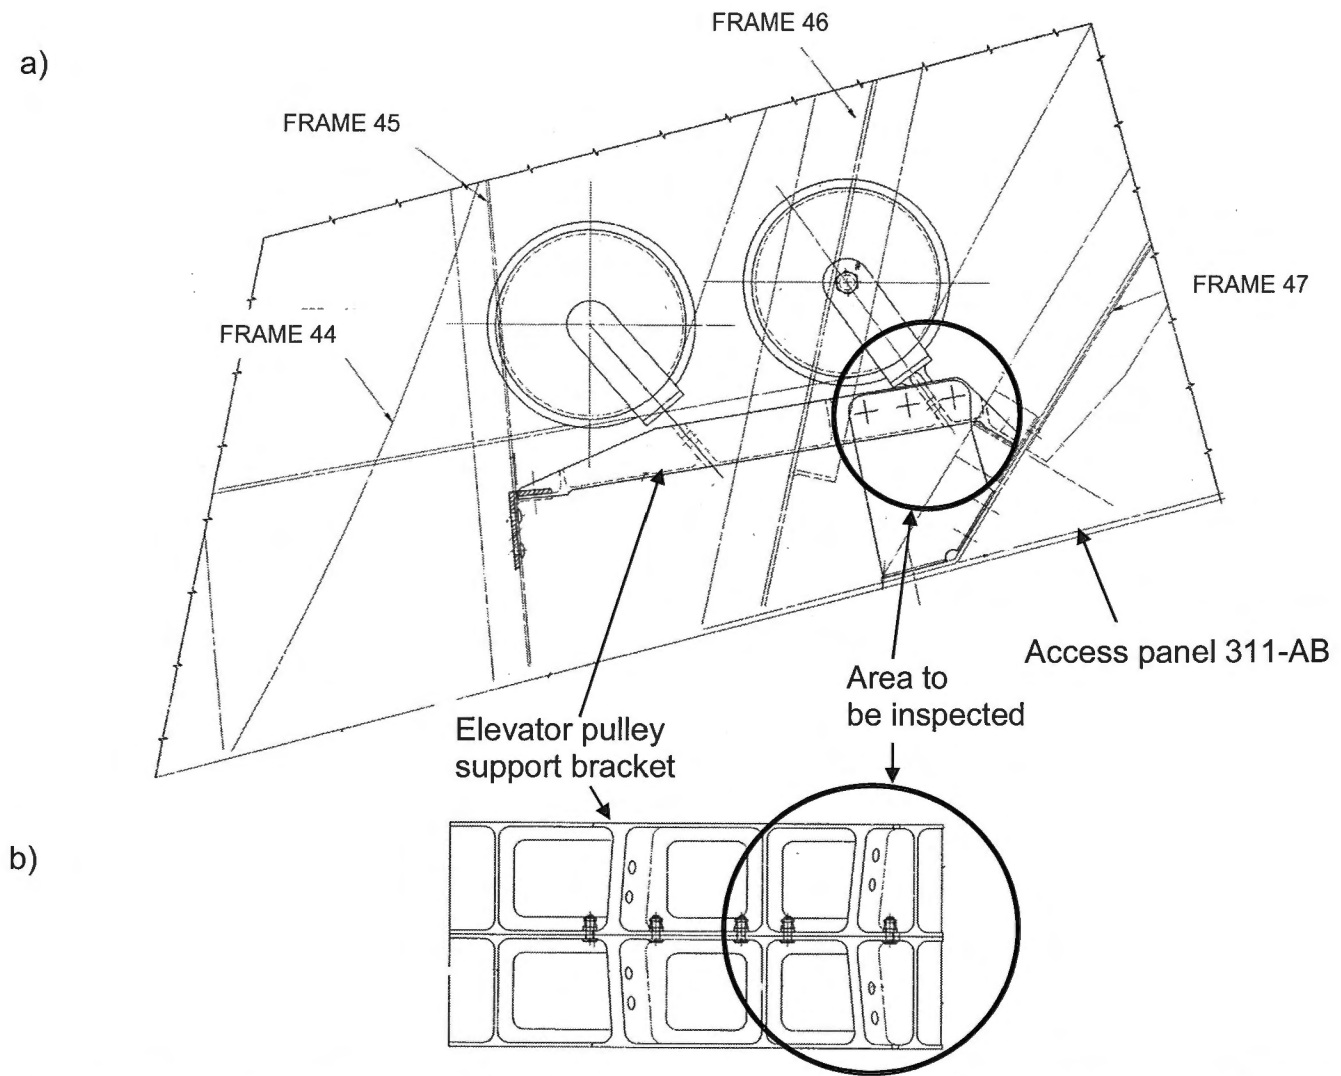
Heavy corrosion has been found on elevator pulley bracket 001A273A3011201.

Figure 1: Elevator pulley support brackets in a) installation and in b) Assembly without pulleys

- (1) Perform a detailed visual inspection according to NTM 51-25-90 for any signs of corrosion and cracks on elevator pulley support brackets and mating parts, see fig. 1 for concerned area. Use appropriate light source, mirror and/or flexible endoscope for inspection from the bottom side.
- (2) Perform eddy current testing for detection of cracks or corrosion according to NTM 51-25-60 on areas shown in figure 2 with focus on the outer edges of the ribs and the bottom of the milled pockets.
A suitable equipment is an Elotest M2 testing device and a KAS 66-3 probe or equivalent equipment (suitable frequencies range from 500 to 700 kHz).

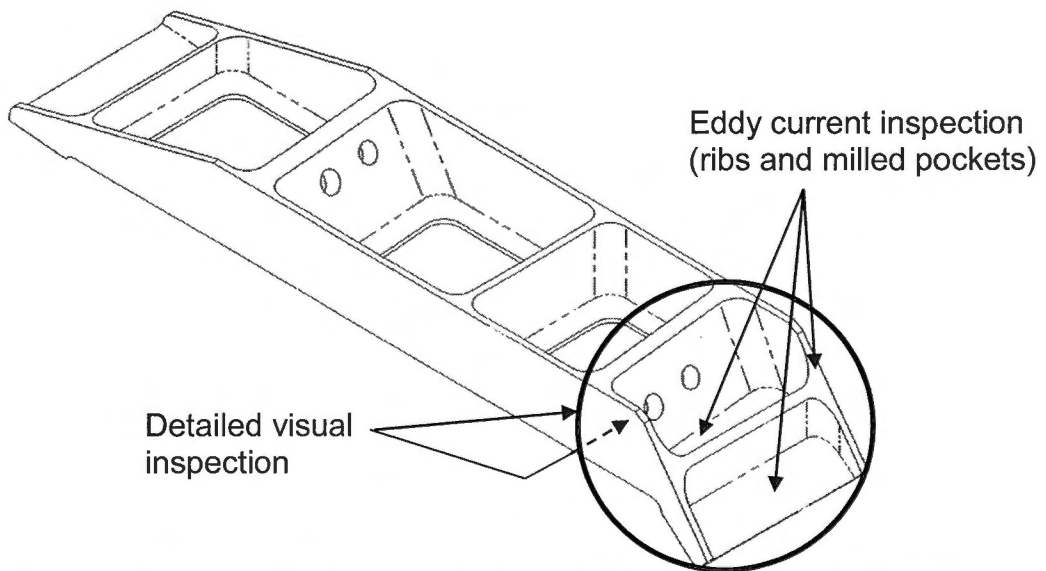
Inspection for signs of corrosion and cracks on the elevator pulley brackets 001A273A3011200 and -201 on all Dornier 328-100 aircrafts.

Figure 2: Inspection areas on brackets 001A273A3011200 (shown) and -201 (symmetric).
