This sheet transmits Revision 2 of Alert Service Bulletin ASB-328-28-041 titled:
Fuel – Inspection of fuel line clamps.

Model: Dornier 328-100

No.: ASB-328-28-041

Title: Fuel – Inspection of Fuel Line Clamps

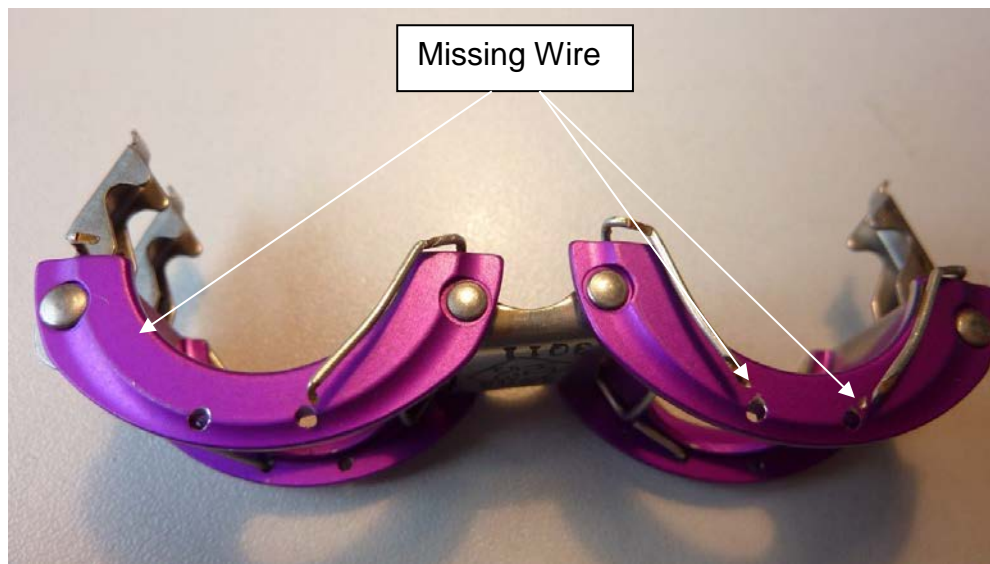
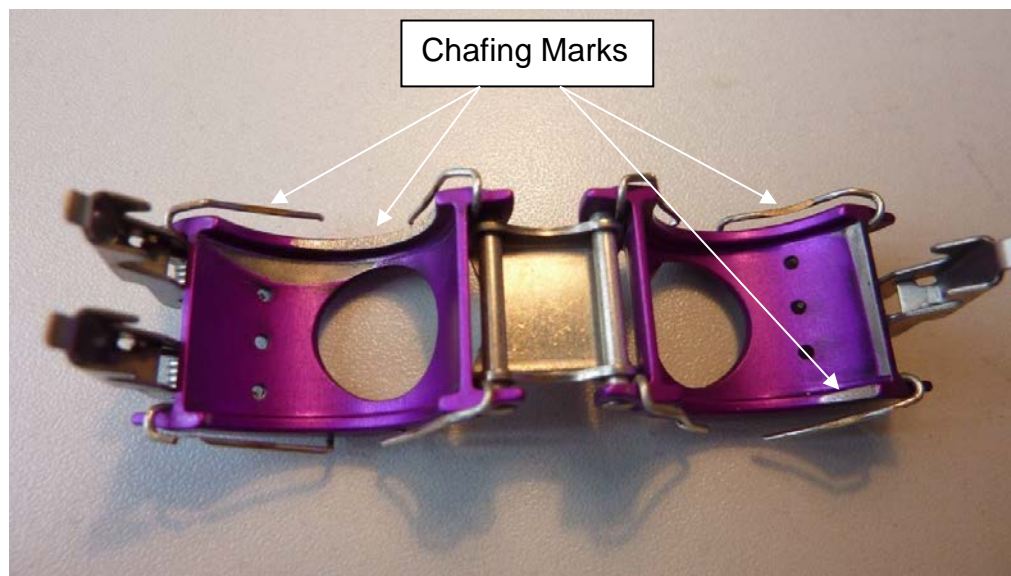
Figure 1: Examples of Reported Damage

Chafing of fuel line clamp bonding wires inside feeder tank.

328 SSG received reports of damaged bonding wires on fuel line clamps in post SB-328-28-490 installations. The basic clamp function is not impaired, but proper bonding and thus lightning protection might be affected. Refer to Figure 1.

In addition, chafing marks on jet pump inlet, connection part and fuel lines occurred.

Parts with chafing marks beyond defined limits have to be replaced.

- 1) Inspect all Hydraflow fuel line clamps at locations A - D for damage of bonding wires in the area. Take pictures of each location for reporting purposes. Refer to Figure 2.
- 2) Open clamps and remove them from tank. Record installation locations.
- 3) Visually inspect clamps for worn or missing bonding wires. If you find worn or missing bonding wires, replace clamp and report the location.
- 4) Visually inspect the jet pump outlet, connection part and fuel lines for chafing marks. Remove parts from tank if chafing marks are found. Refer to the related AMM JIC's.

- 5) Measure depth of chafing marks and compare to the replacement limits defined in table 1.

- 6) Discard parts if depth of chafing is more than the replacement limits.
- 7) Install new parts, and all parts removed in step 4) which are in the replacement limits, to tank. Refer to SB-328-28-490.
- 8) Check installation of jet pumps, connection part and fuel lines for correct alignment and correct if necessary. Maximum allowable deviation is 1 mm.
- 9) Install clamps. Refer to SB-328-28-490. Make sure the alignment is correct
