ASB-328-32-042

Title: Landing Gear - Inspection of R/H Main Landing Gear Side Strut Pin

Dornier 328-100
Type Certificate Data Sheet EASA.A.096
Serial No.: All

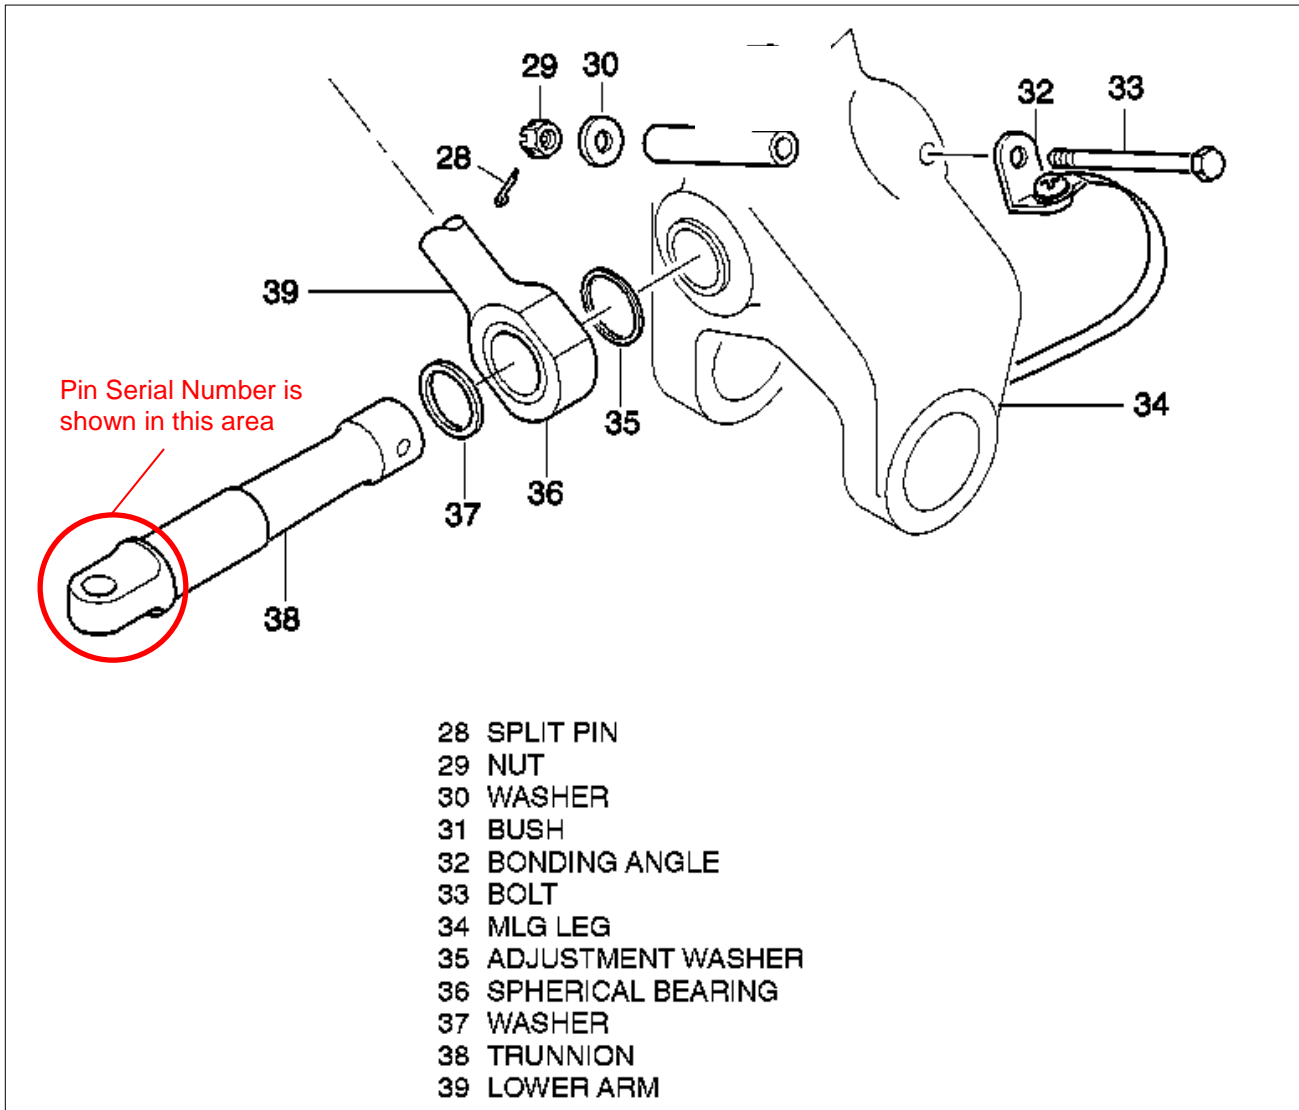
Figure 1: MLG side strut pin

A defined number of MLG side strut pins may have been subject to an improper grinding during final chrome finish, which could lead to a degradation of the pin material properties.

- 1) Identify the Serial Number (S/N) of the RH MLG side strut pin. Refer to Figure 1 for details.

- 2) A replacement pin shall only be ordered from Professional Aircraft Accessories, Inc. (PAA) if evidence is provided, proving that the pin S/N in question is really affected by PAA's recall letter (e.g. photograph report showing the pin S/N together with the SB Compliance Report).
- 3) Remove pin i.a.w. AMM JIC 32-11-06-020-801-A01.
- 4) Perform NDT inspection (magnetic particle or dye penetrant) on outer chrome plated diameter of the pin i.a.w. NTM 51-25-70 or 51-25-80.
- 5) In case of no findings, install pin i.a.w. AMM JIC 32-11-06-420-801-A01, return aircraft to a serviceable condition. Replace pin within 50 FC.
- 6) In case of findings, pin must be replaced before next flight.
