ASB-328J-27-017**Title: Inspection of the Elevator Pulley Support Bracket****1. PLANNING INFORMATION****Effectivity**

Dornier 328-300.
EASA TCDS A.096.
Serial-No's: All aircrafts

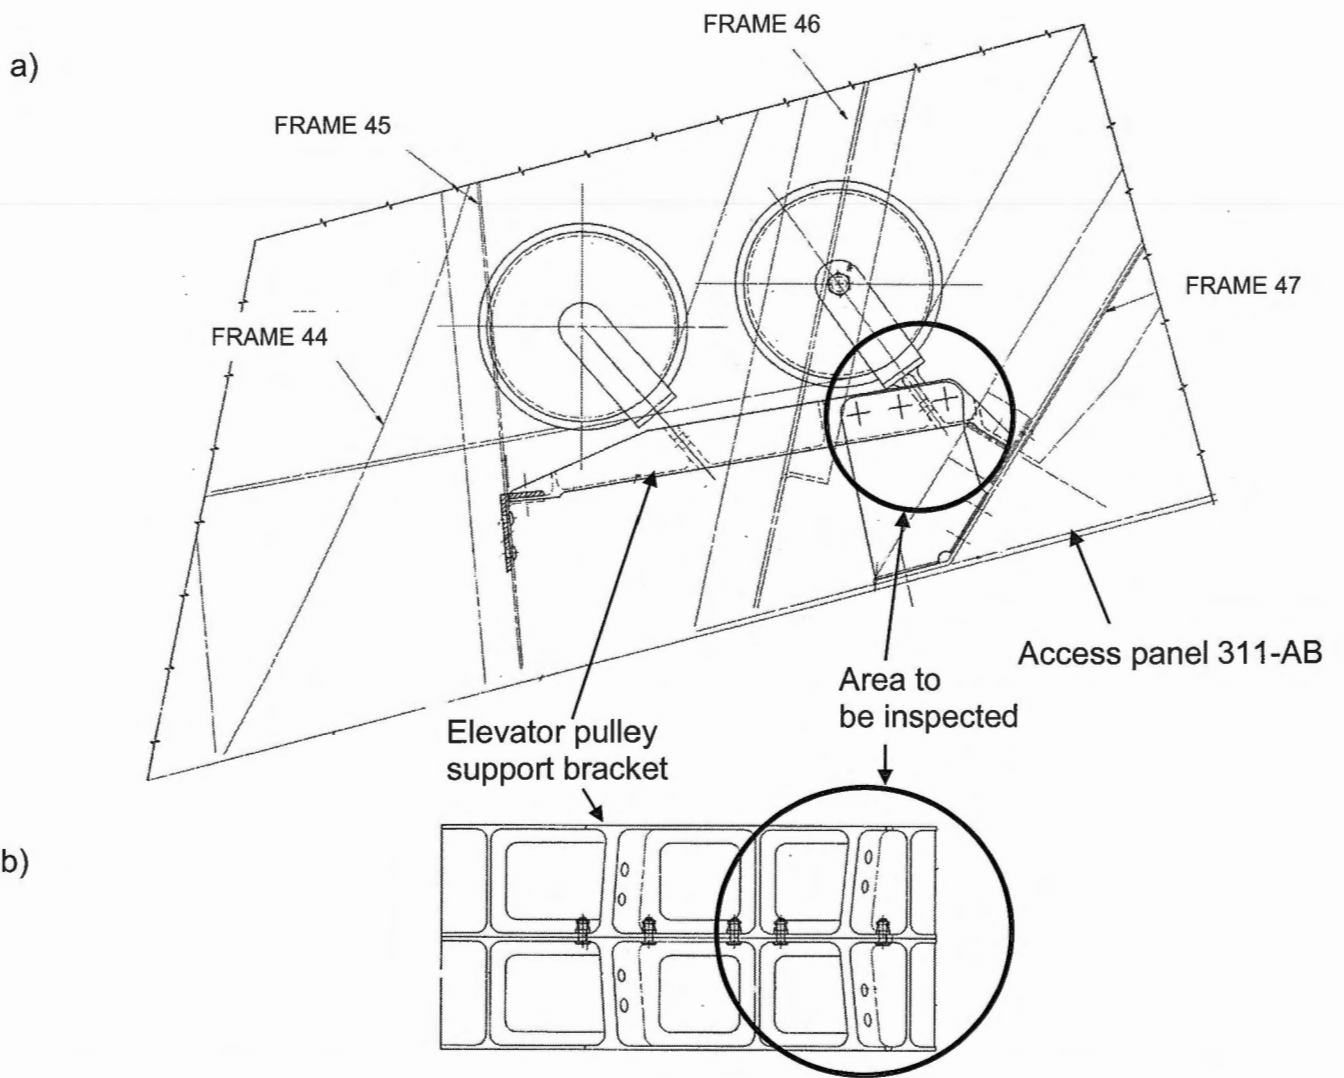
Heavy corrosion has been found on elevator pulley bracket 001A273A3011201.

Figure 1: Elevator pulley support brackets in a) installation and in b) Assembly without pulleys

- (1) Perform a detailed visual inspection according to NTM 51-25-90 for any signs of corrosion and cracks on elevator pulley support brackets and mating parts, see fig. 1 for concerned area. Use appropriate light source, mirror and/or flexible endoscope for inspection from the bottom side.
- (2) Perform eddy current testing for detection of cracks or corrosion according to NTM 51-25-60 on areas shown in figure 2 with focus on the outer edges of the ribs and the bottom of the milled pockets.
A suitable equipment is an Elotest M2 testing device and a KAS 66-3 probe or equivalent equipment (suitable frequencies range from 500 to 700 kHz).

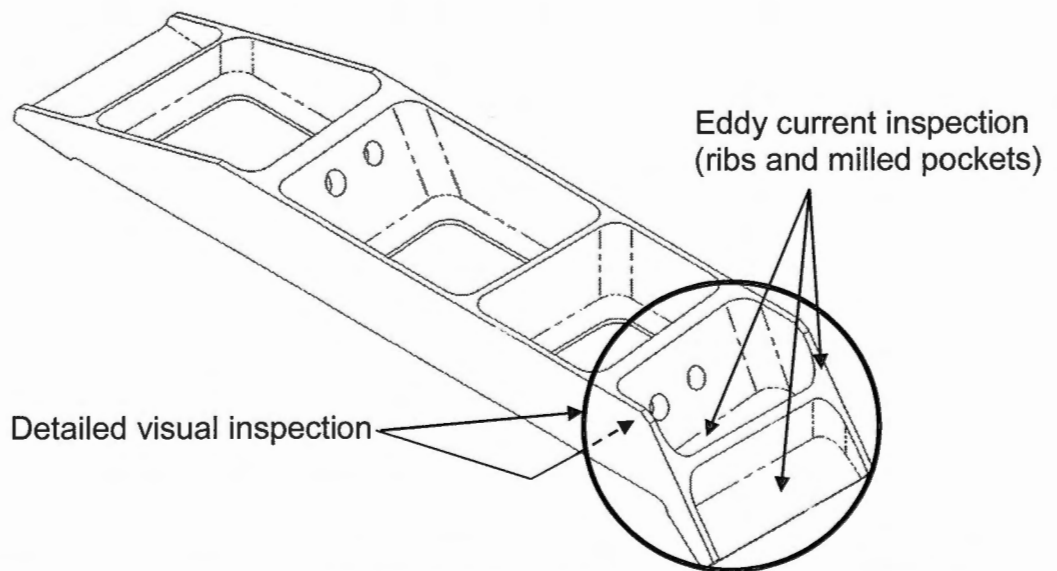
Figure 2: Inspection areas on brackets 001A273A3011200 (shown) and -201 (symmetric).
