ASB-328J-32-020

Title: Landing Gear - Inspection of R/H Main Landing Gear Side Strut Pin

Dornier 328-300
Type Certificate Data Sheet EASA.A.096
Serial No.: All

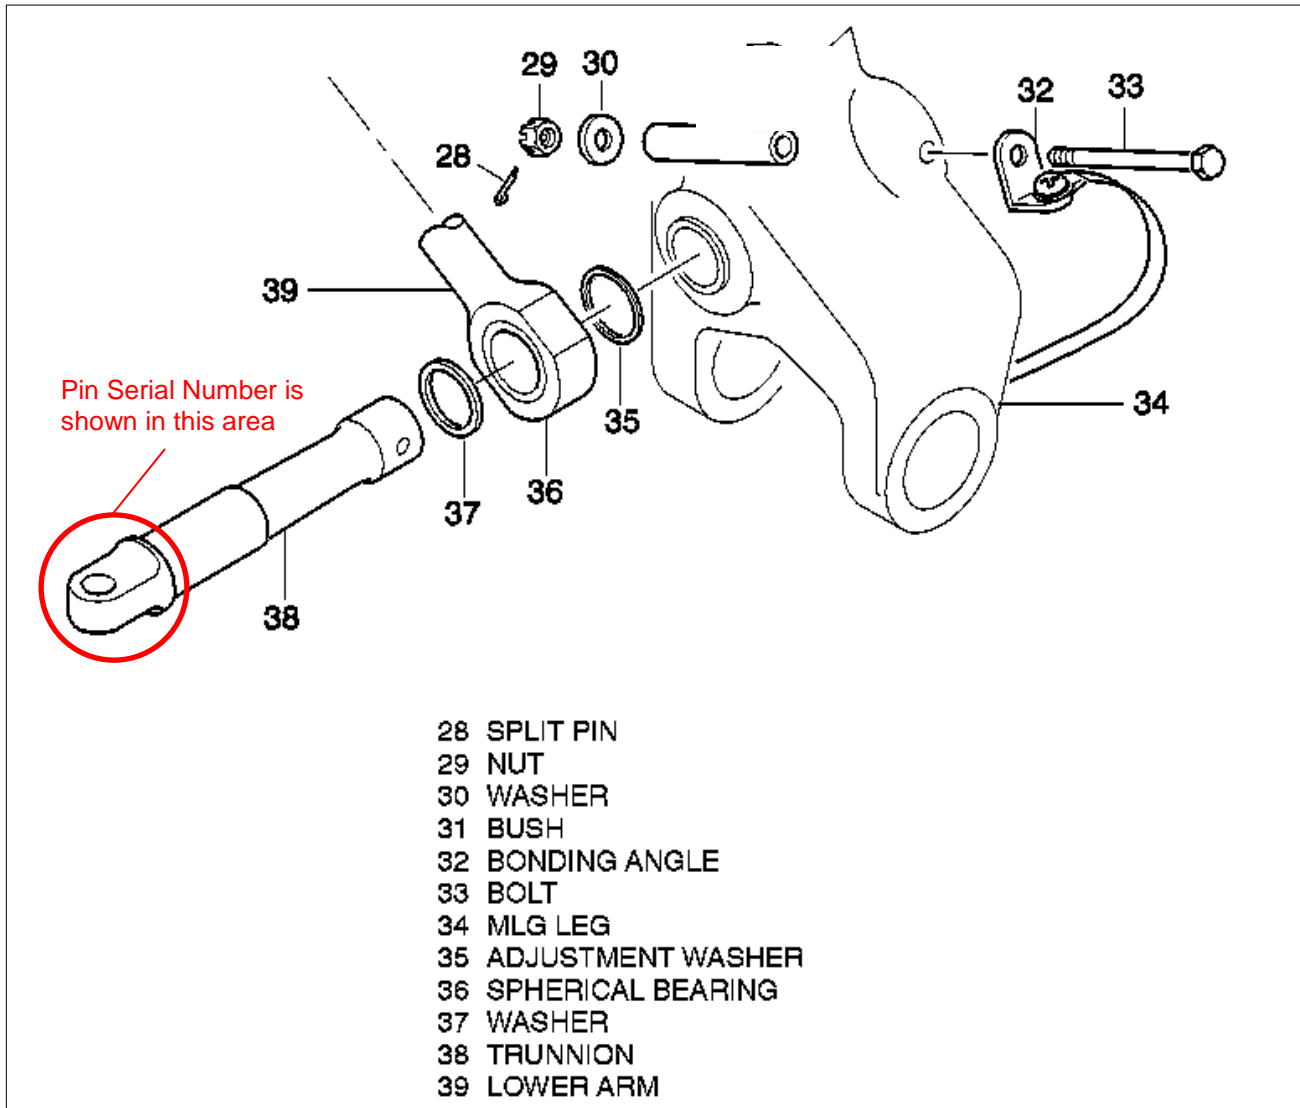
Figure 1: MLG side strut pin

A defined number of MLG side strut pins may have been subject to an improper grinding during final chrome finish, which could lead to a degradation of the pin material properties.

- 1) Identify the Serial Number (S/N) of the RH MLG side strut pin. Refer to Figure 1 for details.

- 2) A replacement pin shall only be ordered from Professional Aircraft Accessories, Inc. (PAA) if evidence is provided, proving that the pin S/N in question is really affected by PAA's recall letter (e.g. photograph report showing the pin S/N together with the SB Compliance Report).
- 3) Remove pin i.a.w. AMM JIC 32-11-06-020-801-A01.
- 4) Perform NDT inspection (magnetic particle or dye penetrant) on outer chrome plated diameter of the pin i.a.w. NTM 51-25-70 or 51-25-80.
- 5) In case of no findings, install pin i.a.w. AMM JIC 32-11-06-420-801-A01, return aircraft to a serviceable condition. Replace pin within 50 FC.
- 6) In case of findings, pin must be replaced before next flight.
